Manhole Inspection Summary

Manhole # S53M__066MH

Location Address: **3201 hudson**

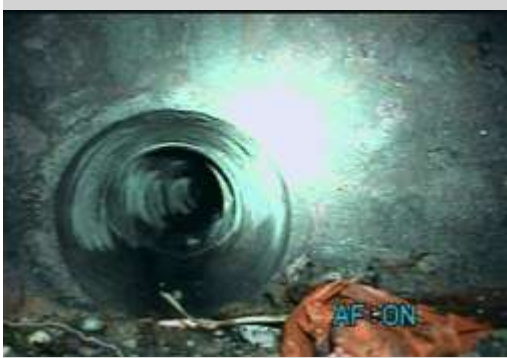
Defect 2

Condition: ☐ Sound ☐ Cracked ☐ Root Intrusion ☐ Deteriorated ☐ Leaks ☒ **Debris**

debris

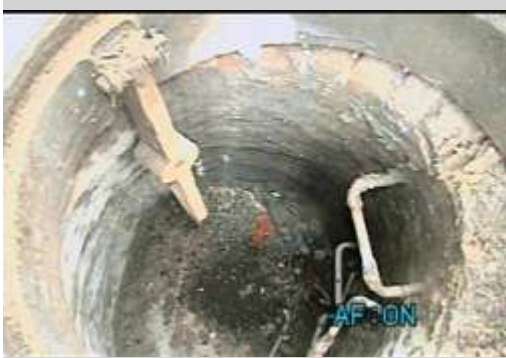
Defect 1

Frame Offset: **3** (in.) Condition: ☐ Sound ☐ Cracked ☐ Leaks

Steps Count: **4** Missing: **0** ☒ **Corroded**

steps corroded, frame offset

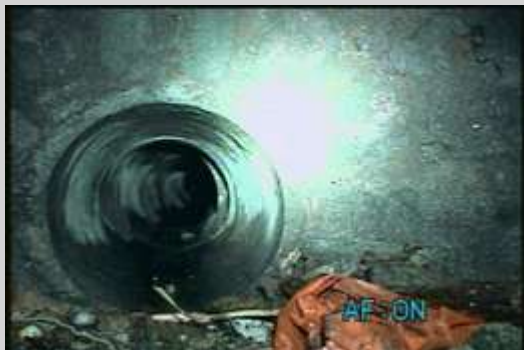
12 O'Clock Outflow

8 in. Circular Gravity Sewer
Pipe Out @ 12 O'Clock
